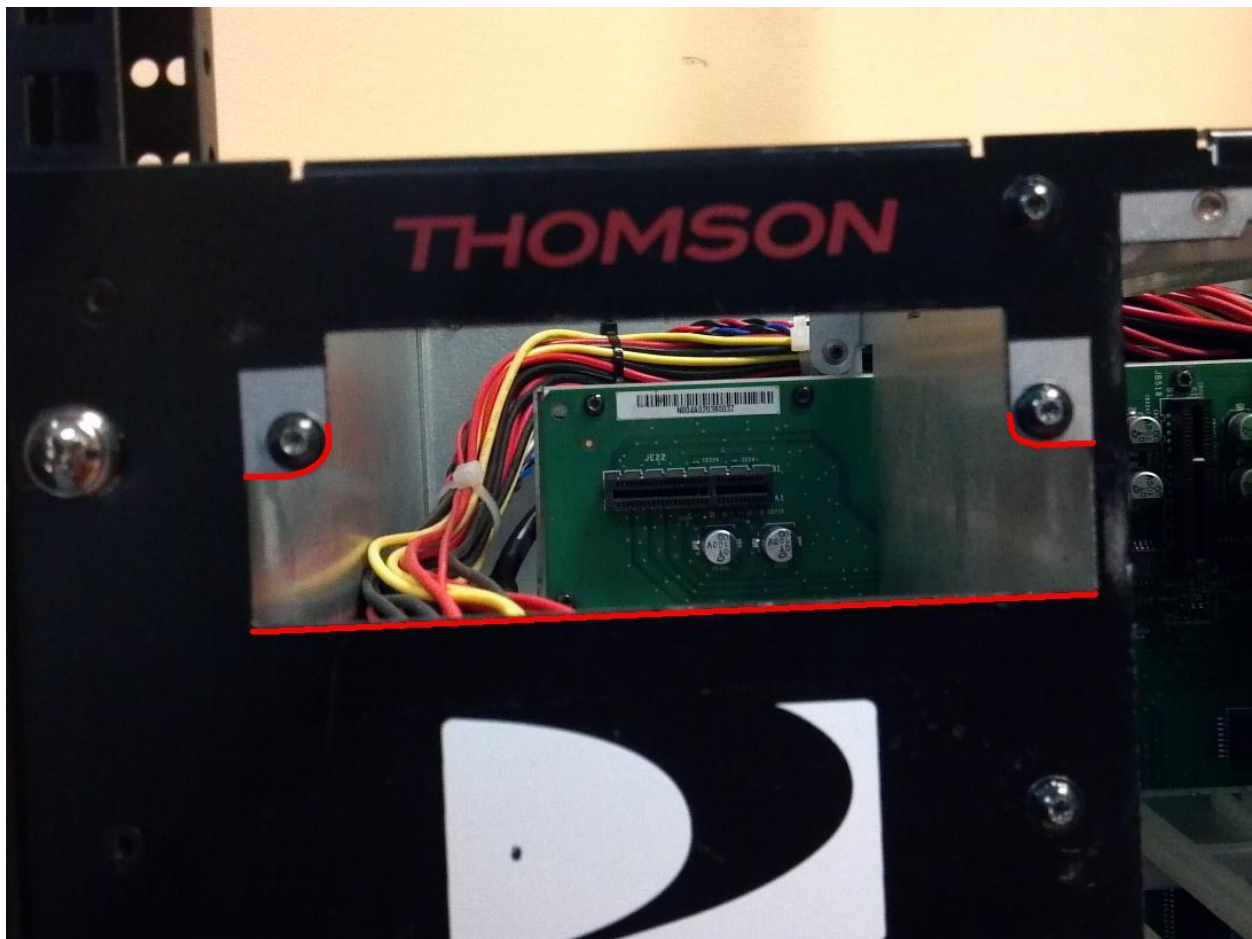
The most probable cause of this damage would be improper care being taken when these assemblies were installed or removed from the chassis. In the picture below I have highlighted in red the areas of the opening were you should not allow the circuit card to come into contact with the chassis. This could have the effect of raking/stripping components from the circuit card assembly.

You should remove the top cover from the chassis and use extra care when installing or removing a QAM24 from the chassis to avoid dragging the circuit board across the edges of the opening in the chassis.
